Ross Martin, Enerflex

Gas Plant Troubleshooting: Assumptions Can Be Expensive – Follow the Data

Wilfred Facility Overview

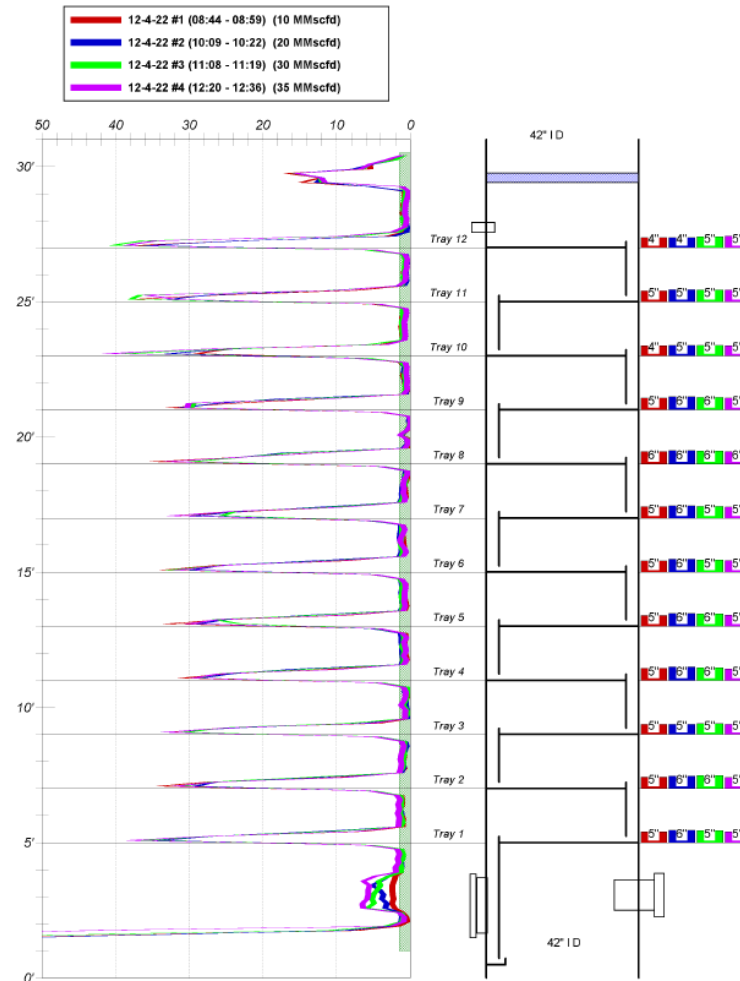
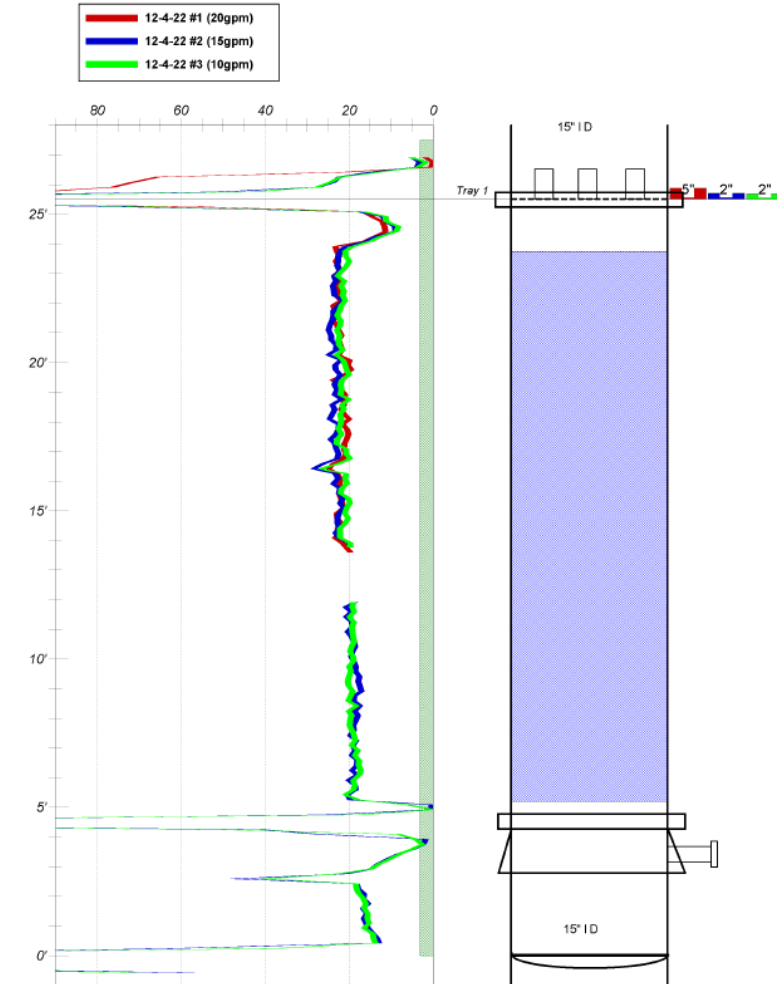
Gamma Scan Results

- Both Contactor and Still Tower were scanned.
- Neither scan revealed anything noteworthy.
- The hydraulics in both towers appeared to be normal and there was no indication that anything was knocked out of place.

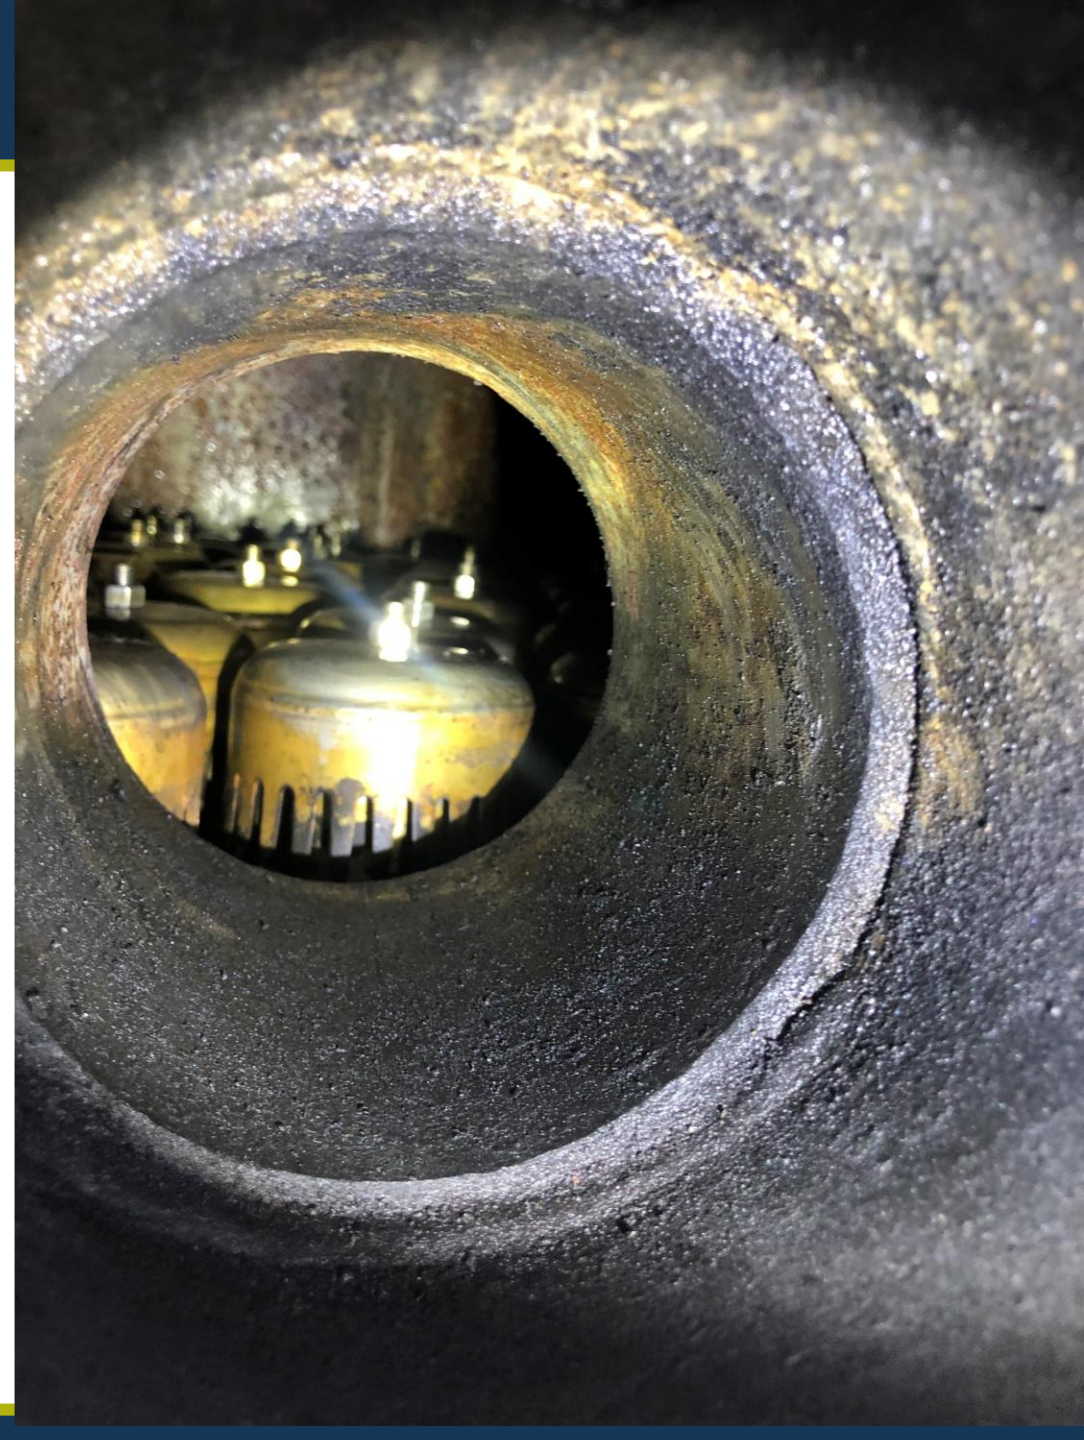
Visual Inspection

- The Contactor was opened for visual inspection.
- No liquid level was visible on the tray decks. For bubble cap trays, liquid level should remain up to the riser.
- A leak test was performed by circulating water through the Contactor.
- The trays that were tested were unable to hold a level.

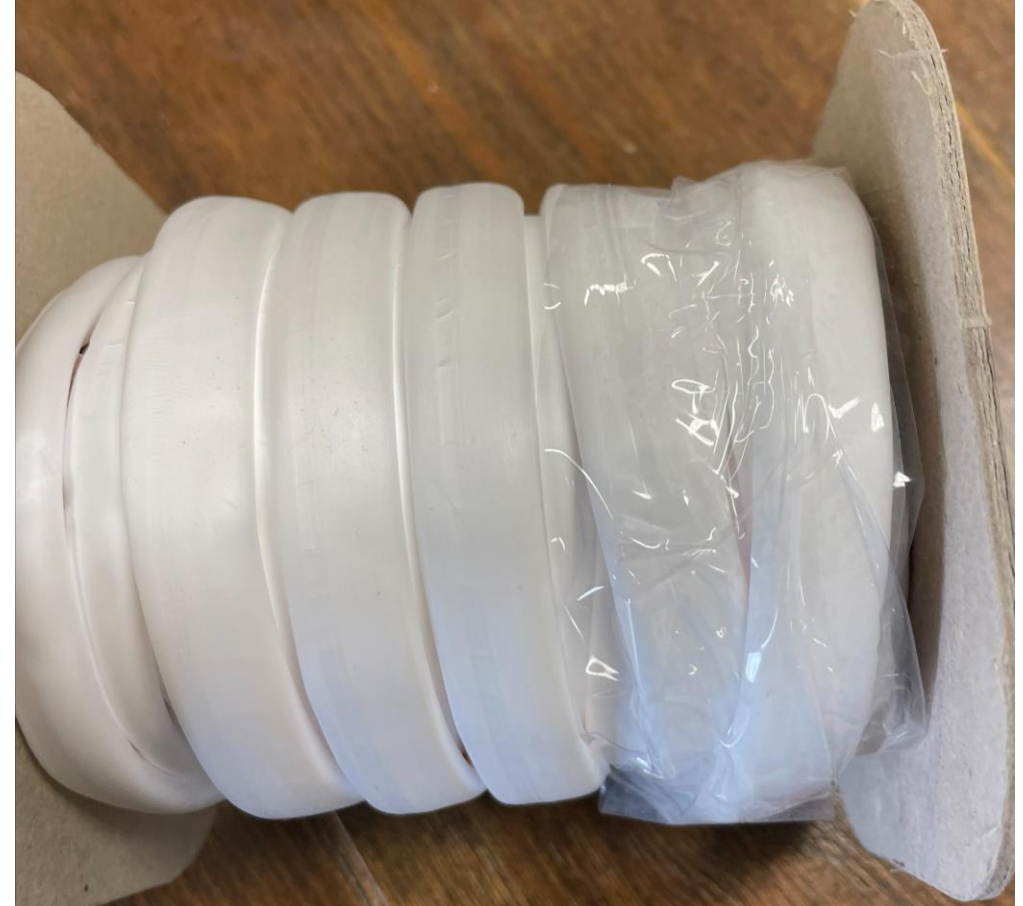
Contactors Tune Up

- Earlier that year, a third-party had replaced the contactor's mist pad. In order to gain access to the mist pad, bubble cap tray manways were removed.
- Tray decks were cleaned and manway gasketing was replaced with a combination of rope style gasketing and ePTFE joint sealant.

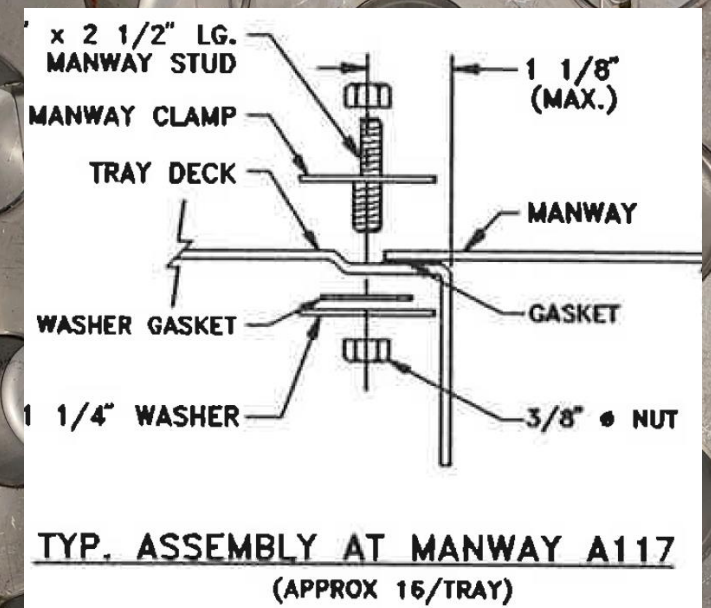
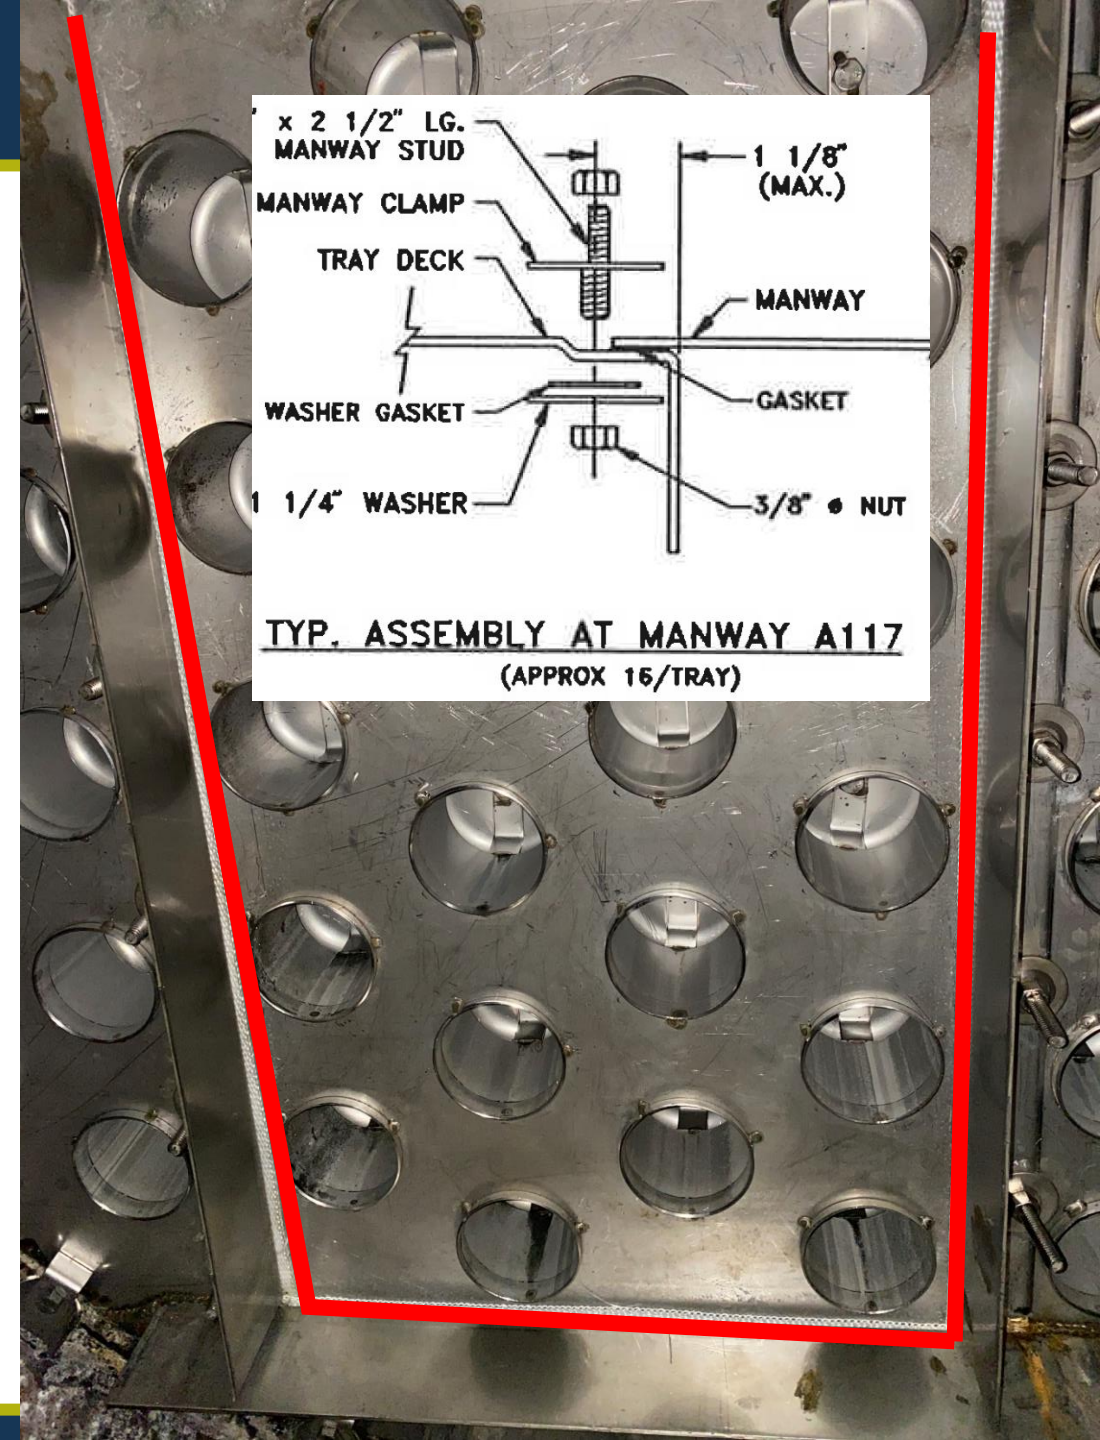
The Diagnosis

- It was confirmed that the leakage was pervasive through the manway gaskets.
- This is mostly due to wear and tear on old hold down clamp assemblies which were unable to provide a tight seal.
- This likely caused internal weeping of amine at turndown conditions.
- At rates >34 MMSCF/D, it is believed that weeping was precluded by the upward flow of gas.
