Ross Martin, Enerflex

Gas Plant Troubleshooting: Assumptions Can Be Expensive – Follow the Data

Wilfred Facility Overview

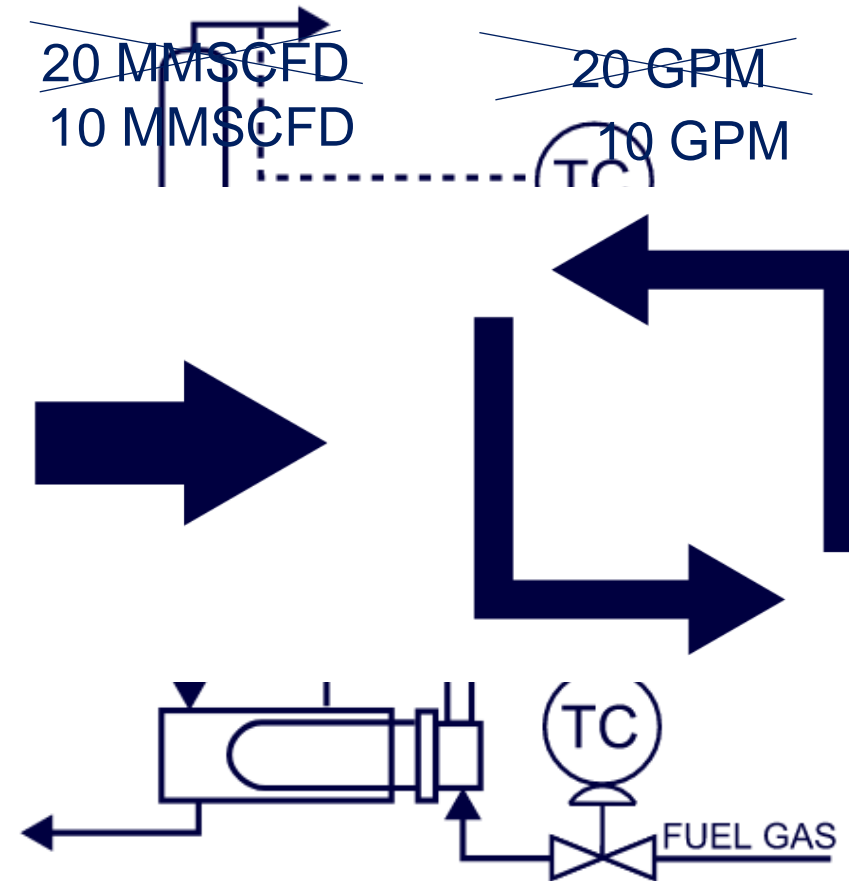
Operational Troubleshooting Steps

- High lean loadings? **Boil harder!**
 - Target: 235°F to 240°F in still overheads
 - Operations achieved 237°F to 239°F with capacity to spare.
 - H₂S concentration in treated gas unaffected.
- Turndown the plant: Both inlet gas and circulation rate.
 - H₂S concentration in treated gas unaffected.

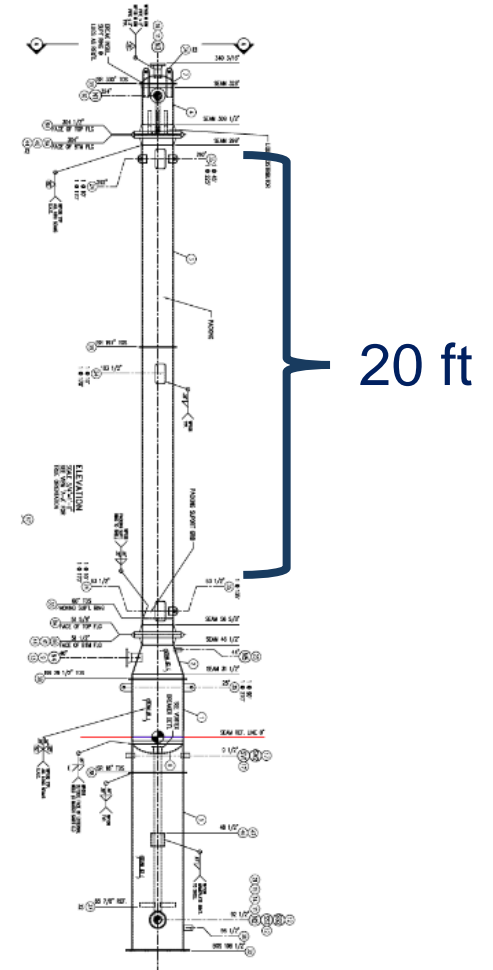
Initial Suspect: Still Tower Packed Bed Height

- Still bed height = 20-foot of packing. The old still column that was replaced was reportedly taller.
- 20-foot bed heights were quoted by two independent internals providers during proposal stage.
- New feedback from the selected internals provider: *“We would like to see 30-foot of packed height.”*
- This would add ~5 stages of mass transfer.
- Alternatively, smaller packing could be provided to add ~2-stages, but limited to 70% of design flow.
- **Short term solution:** Add stripping promoter as suggested by solvent provider.

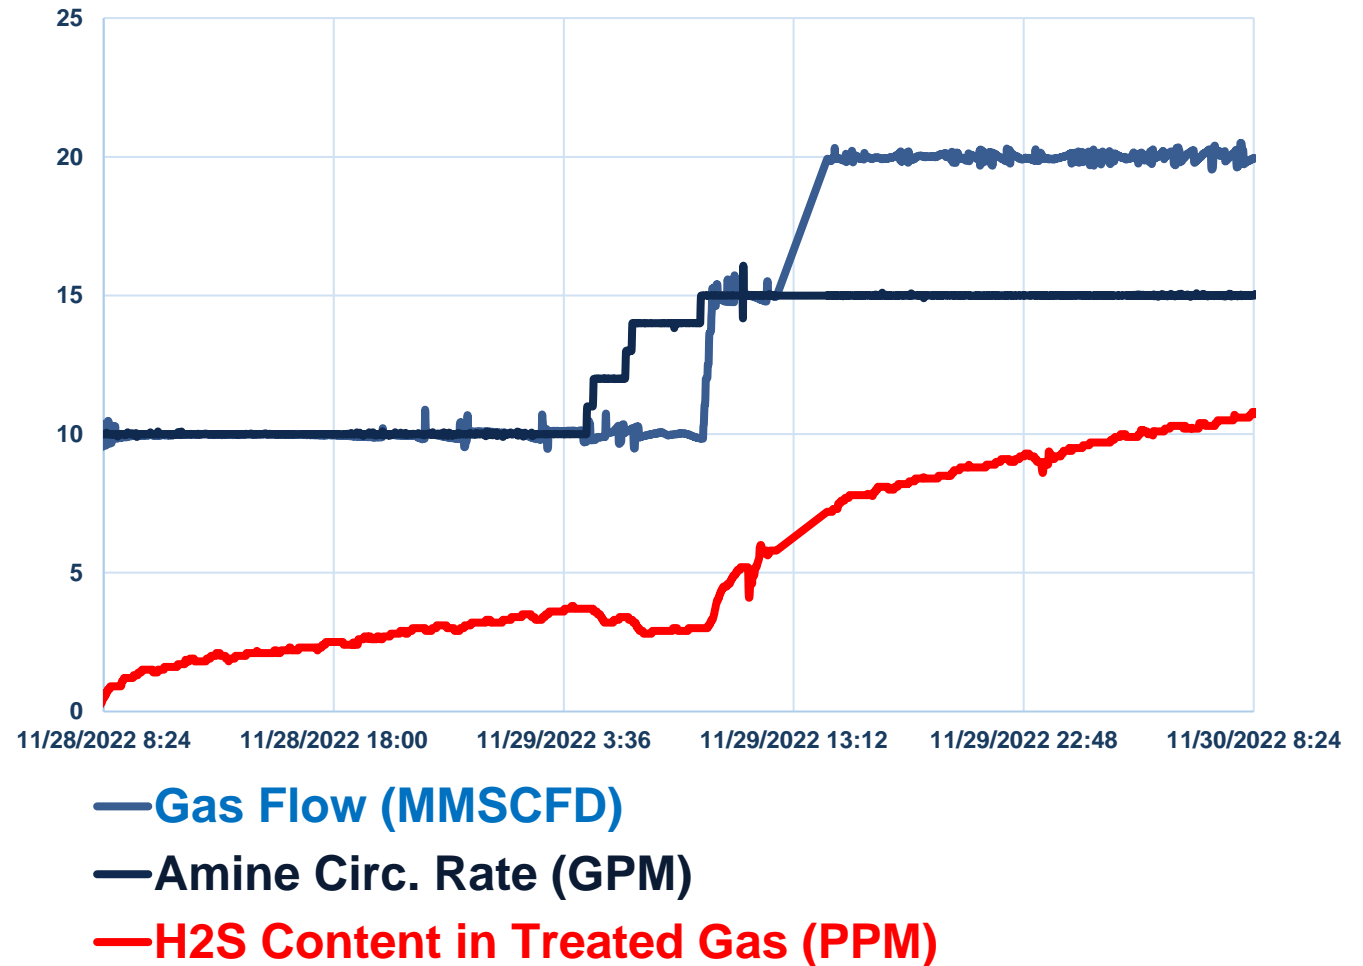
Performance Data After Adding Stripping Promoter

- Stripping promoter added just a few days away from our deadline.
- Over two days, plant slowly stepped up flow from 10 MMSCFD to 20 MMSCFD. H₂S content in treated gas slowly crept up.
 - Day 1 – 2:00 PM: 2 PPM H₂S
 - Day 2 – 5:30 AM: 3.7 PPM H₂S
 - Day 3 – 6:00 PM: 8.3 PPM H₂S
 - Day 4 – 8:00 AM: 10.8 PPM H₂S

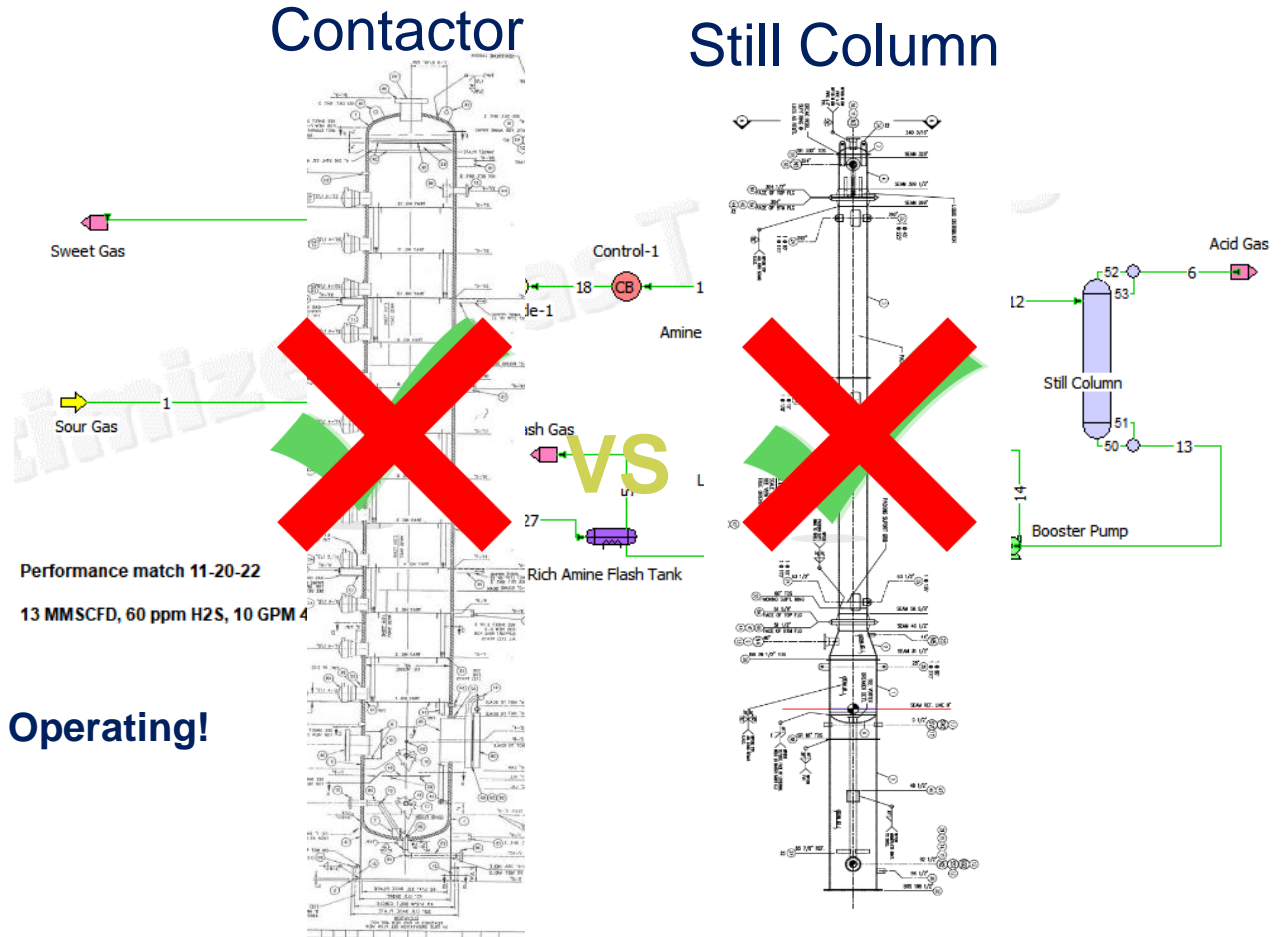
ProTreat Analysis Part II

- Case 1: No deration in Still Columnn or Contactor
- Case 2: Still column issues
- Case 3: Contactor issues

Summary Table		Case 1	Case 2	Case 3
Lean Loading (H2S)	mol/mol	0.0002	0.00682	0.00186
Still Ovhd Temp	F	225.24	181.2	225.24
Still Bottoms Temp	F	240.67	212.4	240.37
Reboiler Duty	MMBTU/hr	1.1	0.3	0.47
Trays in Contactor		12	12	2
Outlet H2S Content	ppm	0.19	10.14	14.27

*All cases assume 20 MMSCFD, 60 ppm inlet H2S, 15 GPM circ. rate.

225.24 F Operating!

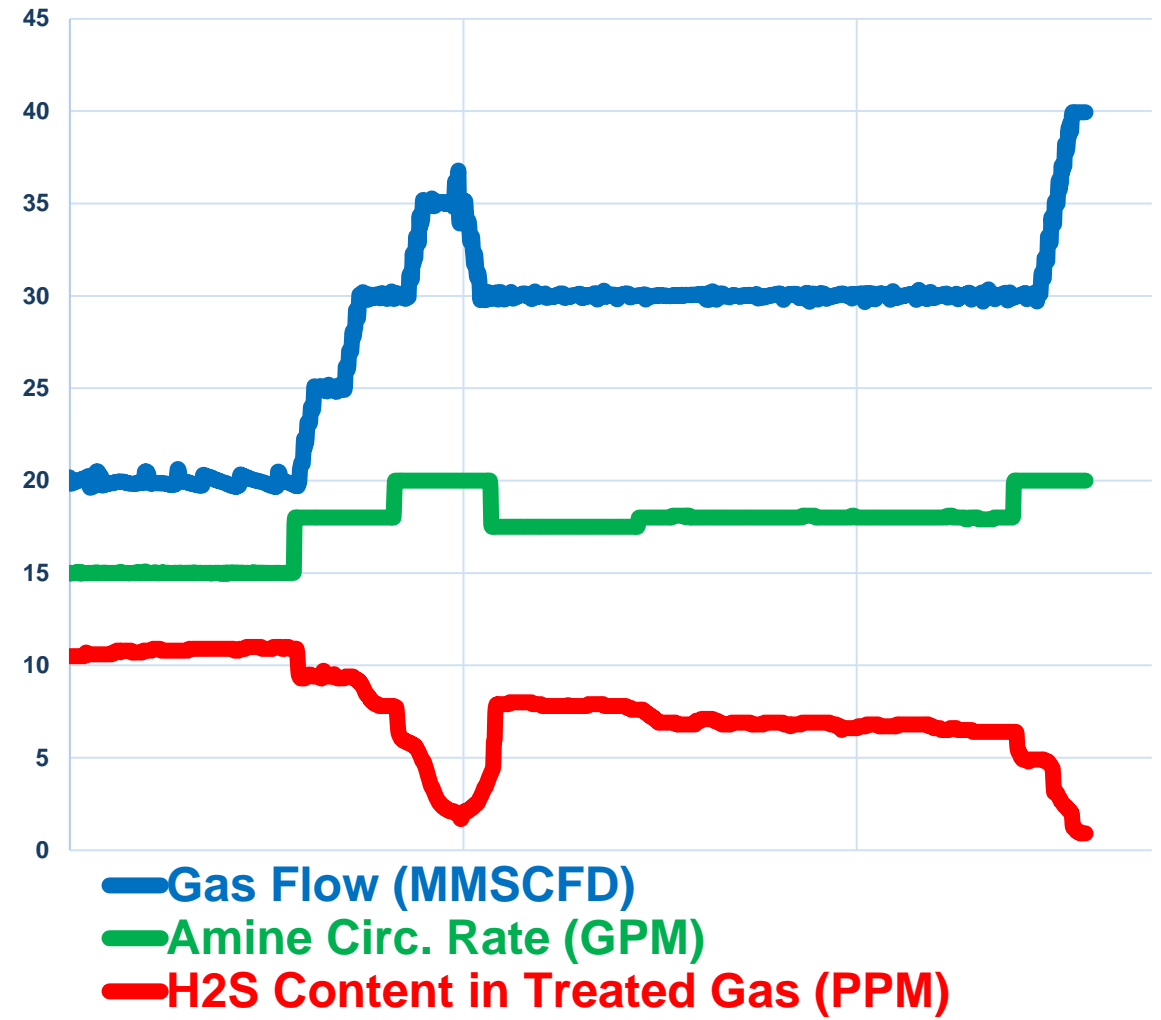
Performance Data During Turnup

- Operations continued to increase the flowrate throughout the three days. Interesting things then started to happen.
- H₂S content in the treated gas was observed to drop off significantly at inlet gas rates greater than 34 MMSCFD!
